NASA SP-238

APOLLO 11

Mission Report

PREPARED BY
MISSION EVALUATION TEAM
NASA MANNED SPACECRAFT CENTER

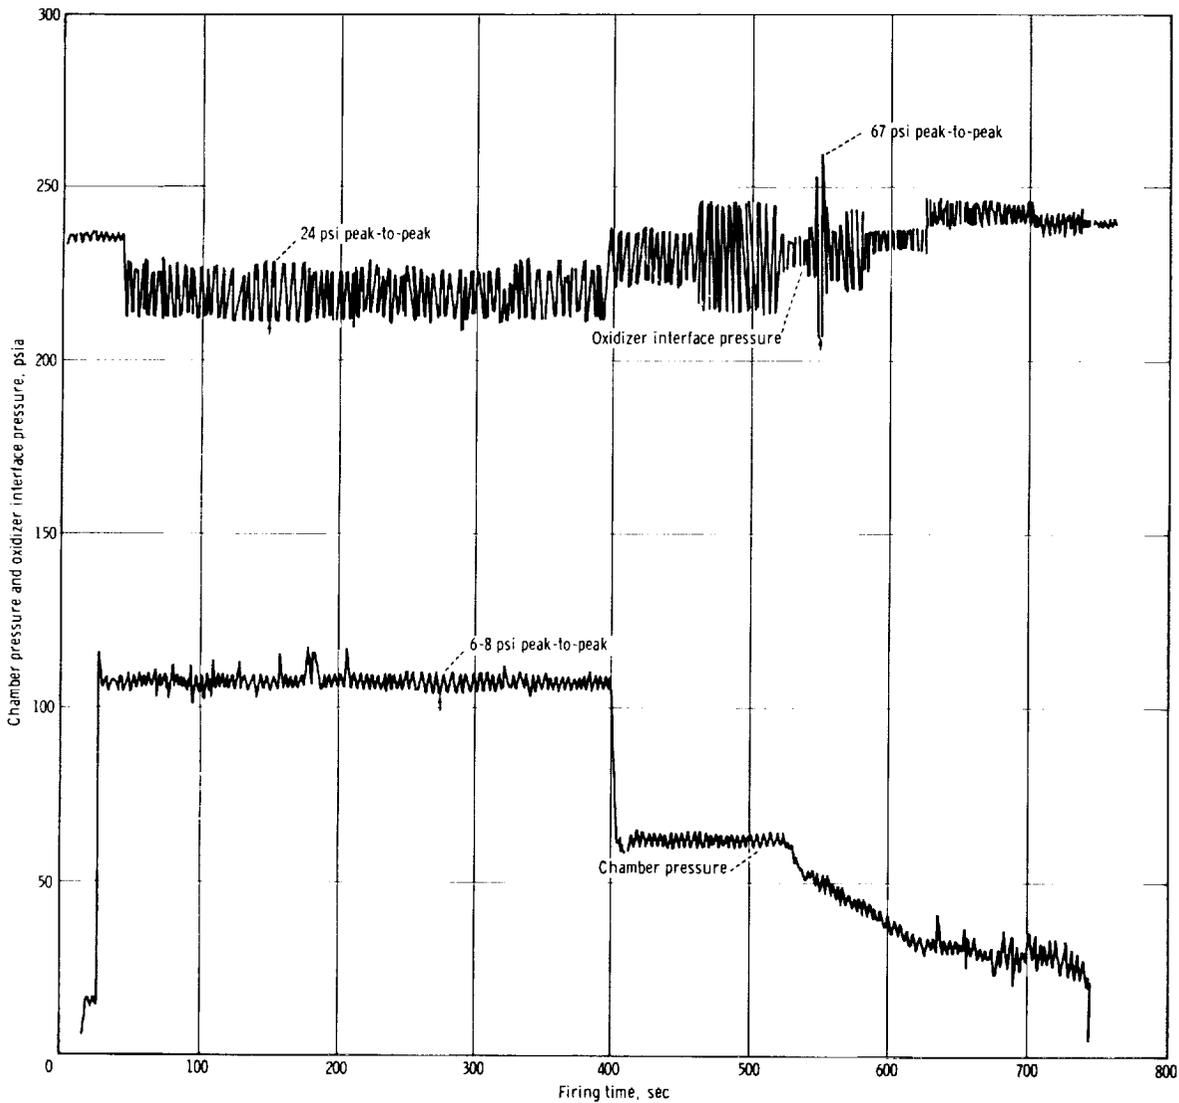
Figure 9-5.- Oxidizer interface pressure and chamber pressure oscillations.

During the powered descent maneuver, the oxidizer interface pressure appeared to oscillate as much as 67 psi peak to peak. The pressure continued to oscillate throughout the firing, although over a smaller range (fig. 9-5); the oscillations were most prominent at approximately 50-percent throttle. The fact that oscillations of this magnitude were not observed in the chamber pressure or the fuel interface pressure measurements indicates that they were not real. Engine performance was not affected. Oscillations of this type have been observed at the White Sands Test Facility on similar pressure measurement installations on numerous engines. The high-magnitude pressure oscillations observed during the White Sands Test Facility tests were amplifications of much lower pressure oscillations in the system. The phenomenon has been demonstrated in ground tests where small actual oscillations were amplified by cavity resonance of a pressure transducer assembly containing a tee with the transducer on one leg of the tee and a cap on another leg. This assembly is similar to the interface pressure transducer installation. The resonance conditions will vary with the amount of helium trapped in the tee and with the throttle setting.

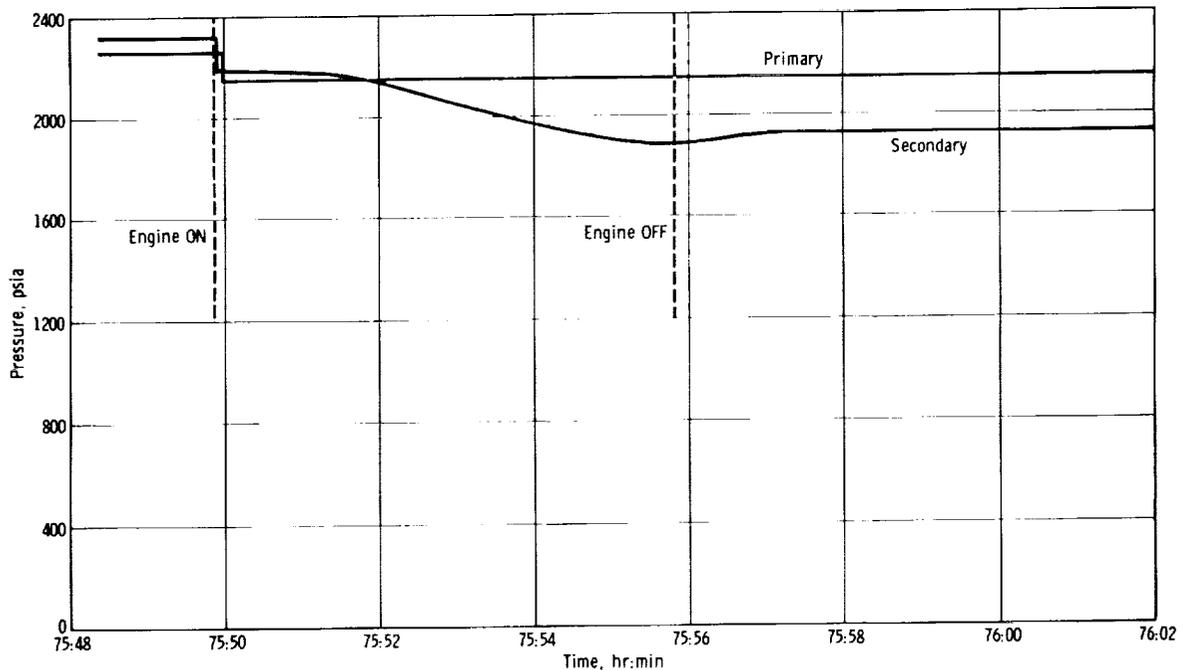
Figure 16-1.- Nitrogen pressure during initial lunar orbit insertion firing.

Service propulsion nitrogen leak.- During the lunar orbit insertion firing, the gaseous nitrogen in the redundant service propulsion engine actuation system decayed from 2307 to 1883 psia (fig. 16-1), which indicated a leak downstream of the injector prevalve. The normal pressure decay as experienced by the primary system is approximately 50 psia for each firing. Only one system was affected, and no performance degradation resulted. This actuation system was used during the transearth injection firing, and no leakage was detected.

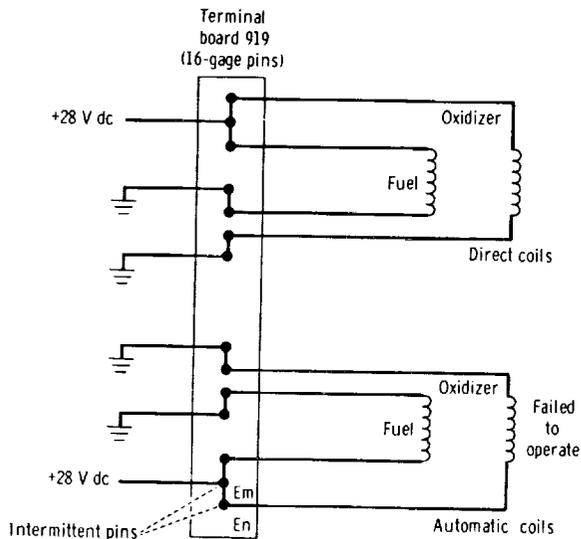
Figure 16-3.- Terminal board schematic for minus-yaw engine, command module reaction control system 1.

Postflight tests showed that two pins in the terminal board (fig. 16-3) were loose and caused intermittent continuity to the automatic coils of the engine valve. This type

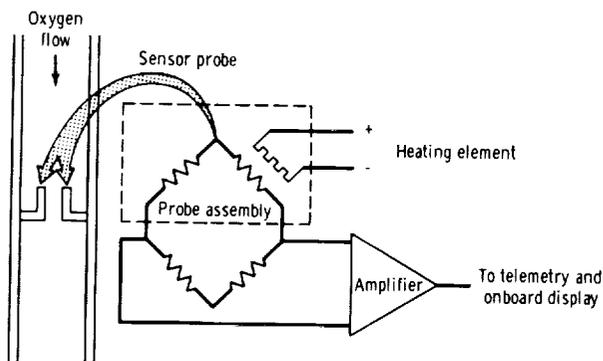
Figure 16-5.- Oxygen flow sensor.

Analysis of associated data indicated that the oxygen flow was normal, but that the indicated flow rate was negatively biased by approximately 1.5 lb/hr. Postflight tests of the transducer confirmed this bias, and the cause was associated with a change in the heater winding resistance within the flow sensor bridge (fig. 16-5). The resistance of the heater had increased from 1000 to 1600 ohms, therefore changing the temperature of the hot wire element that supplies the reference voltage for the balance of the bridge. Further testing to determine the cause of the resistance change was not practical because of the minute size of the potted resistive element. Depotting of the element would destroy available evidence of the cause of failure. Normally, heater resistance changes occur early in the 100-hour burn-in period during which heater stability is achieved.

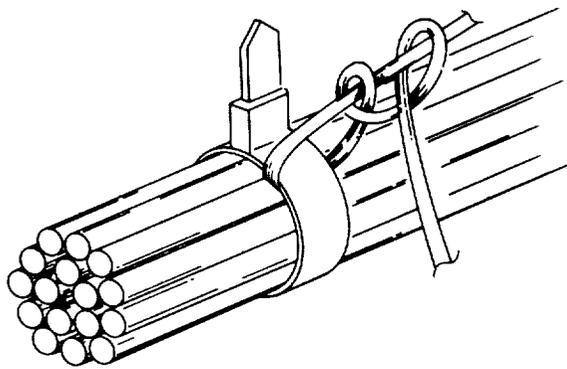
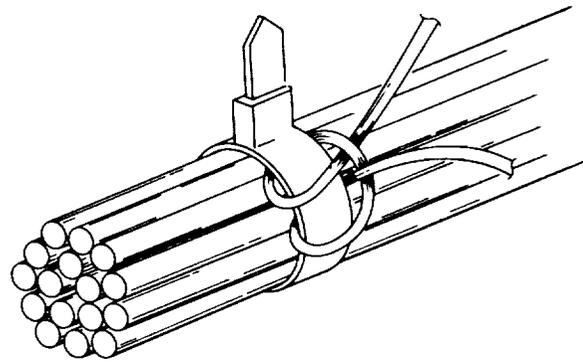
After the lanyard breaks the tie-wraps, if the fragment of tie-wrap pulls out of the knot, the clove hitch knot can untie, thus lengthening the lanyard. Lengthening this lanyard as the umbilical cable pays out can allow transfer of some loading into the umbilical disconnect fittings. Should a sufficient load be transferred to the disconnect fitting to cause shearpins to fail, the mortar umbilical of the forward heat shield could be disconnected prior to the mortar firing. This disconnection would prevent deployment of the forward heat shield separation-augmentation parachute, and there would be a possibility of forward heat shield recontact with the command module. Examination of the forward heat shield recovered from Apollo 10 confirmed that the mortar had fired and that the parachute was properly deployed.
